**INSTRUCTIONS FOR CONTINUED
AIRWORTHINESS**

**FOR
CONQUEST 425 AIRCRAFT**

**WITH
ELECTRONIC TORQUE INDICATION SYSTEM**

Document No. 200707-30

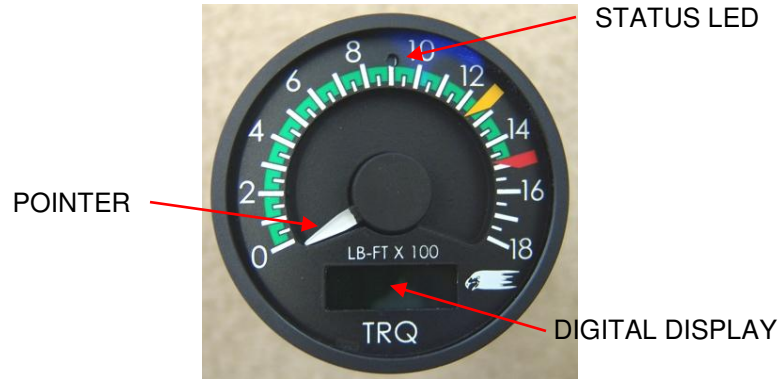
Figure 1. Face of Torque Indicator

Each original torque indicator has been replaced by an electronic, micro-processor based indicator (Figure 1). Each indicator

1. is electrically powered by the DC electrical bus for the engine instruments through a 5 amp circuit breaker.
2. indicates the engine torque based upon a voltage signal from a DC powered pressure transducer mounted on the left side of the engine gear box flange.
3. displays the torque indication via the familiar rotating pointer showing power trends and torque limitations against a fixed scale plate, but now also provides better accuracy via a digital display.
4. includes a two-color (green/red) status LED.
5. is backlit and dimmable using the existing engine indicator lighting rheostats. Note: original post-lights have been removed.

Upon initial power up, each indicator performs a self-test. During this test and prior to assuming normal operation,

1. the digital display initially displays “OK”, followed by “----”, then when the self test is complete the actual engine torque indication.
2. the status LED illuminates red then green, then extinguishes.
3. the pointer is driven from off scale to the full scale position, followed by the off scale zero position, then displays the actual torque indication.

During normal operation each indicator is conducting a continuous self-test on the indicator and the transducer’s signal. The result of this self-test is displayed using the status LED which is defined in Table 1 below.

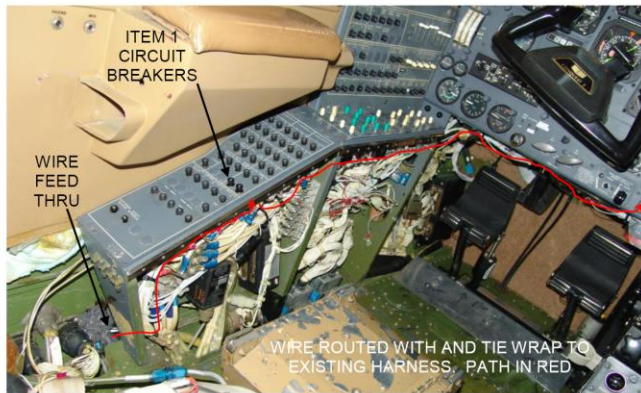
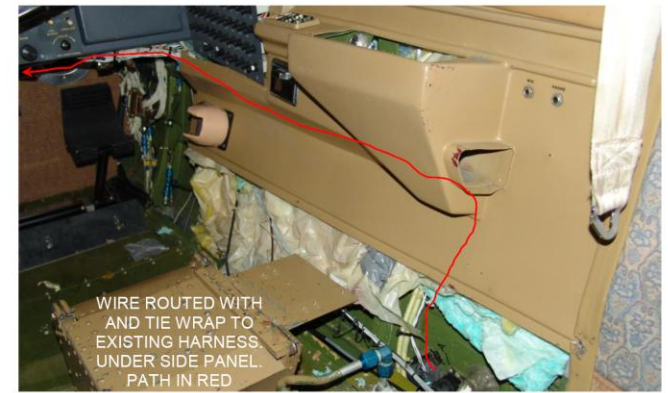
Figure 3. Typical Wiring Routing for S/N 425-0002 thru S/N 425-0204 without SK425-21 incorporated (Cont.)

LEFT SIDE OF CABIN

RIGHT SIDE OF CABIN

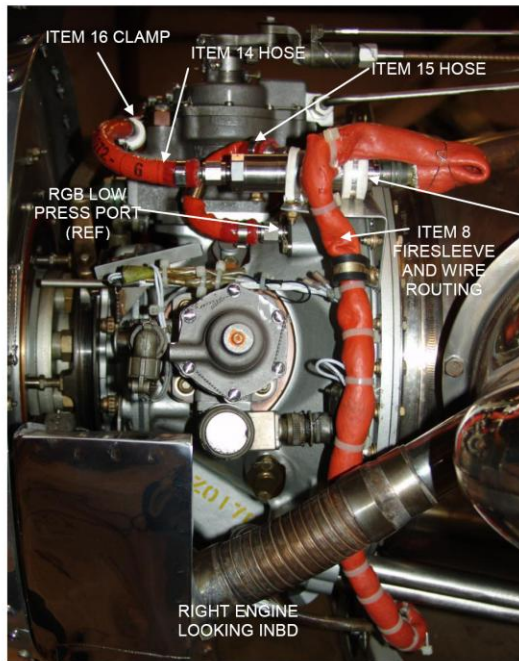
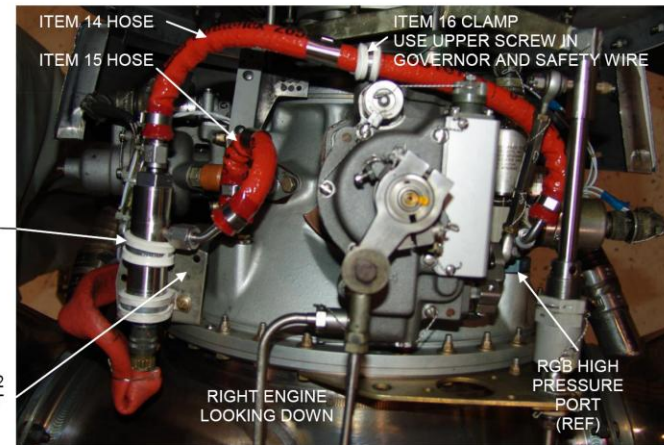
Figure 4. Typical Torque Transducer and Hose Installation for S/N 425-0002 thru S/N 425-0204 without SK425-21 incorporated

ITEM 17 CLAMP
ITEM 21 WASHER
ITEM 20 SCREW
ITEM 26 NUT
(2 PLACES)

TRANSDUCER INSTALLATION AND HOSE CONNECTION
(APPLICABLE TO S/N 425-0002 THROUGH 425-0204 WITHOUT SK425-21 INSTALLED)
(FIRESLEEVE INSTALLATION APPLICABLE TO ALL INSTALLATIONS)

1. mounted on the left side of the engine gear box flange,
2. powered by the same DC bus as for the engine instruments, and
3. sensing a high and low gear box oil pressure and converts this differential pressure into an electrical voltage which is the input to the cockpit torque indicators.

Refer to Chapter 77-10-04 Page 201 Section 2.A and 2.B in basic Cessna Model 425 Maintenance Manual for removal and installation of torque transducer or indicator except refer to Figure 4.
